GERMAN COCKROACHES IN A COMMERCIAL BAKERY.

CASE STUDY

Thorough inspections uncovered a significant cockroach problem in a commercial bakery. Learn how our experts solved it.

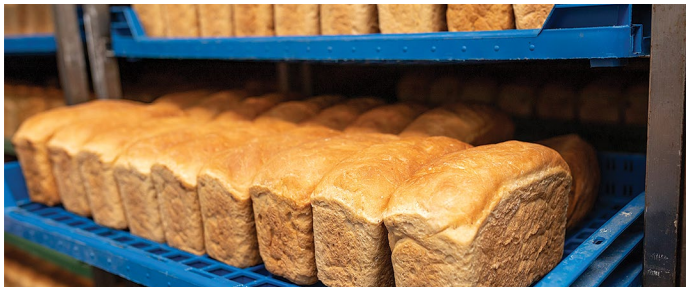
To identify the source of the infestation, our experts conducted a thorough initial inspection. They found German cockroaches heavily concentrated at the base of walls and doors of the walk-in proofer ovens. Since exposed bakery products were moved in and out of these proofers on carts, the presence of cockroaches there posed a serious food safety risk due to potential direct contact with the food. The inspection also revealed cockroaches around oven insulation and in the product mixing areas. However, no cockroaches were found in the storage areas, and only limited numbers were identified in the packaging area, confirming the infestation was centered around the production and processing equipment.

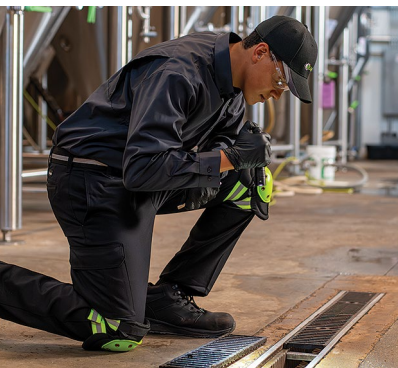
Monitoring, inspection, and treatment efforts revealed cockroaches not only in the ovens but also in the complex walls of the mixing tanks. The tanks had outer stainless steel seals that were compromised, allowing moisture to seep into the insulation layer, creating an ideal environment for cockroaches. After consultation, it was determined that the mixing tank design needed modification to eliminate this significant harborage point.

This successful cockroach elimination utilized Integrated Pest Management (IPM), centered on intensive inspection and monitoring to locate all hidden harborage sites, like in the oven and mixer insulation. Working with the client, equipment modifications were made to both eliminate current issues and prevent future infestations. Chemical treatments alone would have failed without these changes. Ongoing monitoring and visual inspections remain essential to quickly address any new pest activity.
